PERFORMANCE OF INCONEL 550 TURBINE BLADES

IN A TURBOJET ENGINE AND EFFECTS OF

DIFFERENT FORGING TEMPERATURES

AND HEAT TREATMENTS

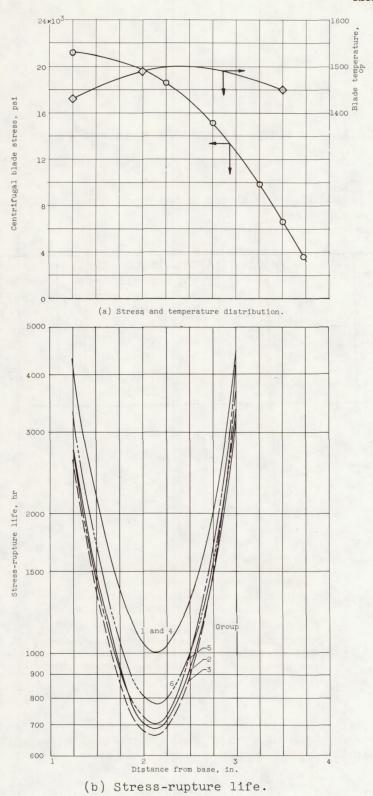
The minimums of the curves of figure 1(b) define the best possible lives that could be expected from the different groups of blades and also locate a point where fracture by stress rupture should occur. This point is about  $2\frac{1}{8}$  inches from the base of the airfoil. The curves do not express the true scatter of the data but represent the average data. Thus the minimums could perhaps more correctly be represented by a scatter band or zone. The small sampling of data does not, however, seem to warrant the drawing of such a zone.

Figure 1. - Stress and temperature distribution in Inconel 550 turbine blade at rated speed and corresponding stress-rupture life of specimens cut from airfoils of group l blades.

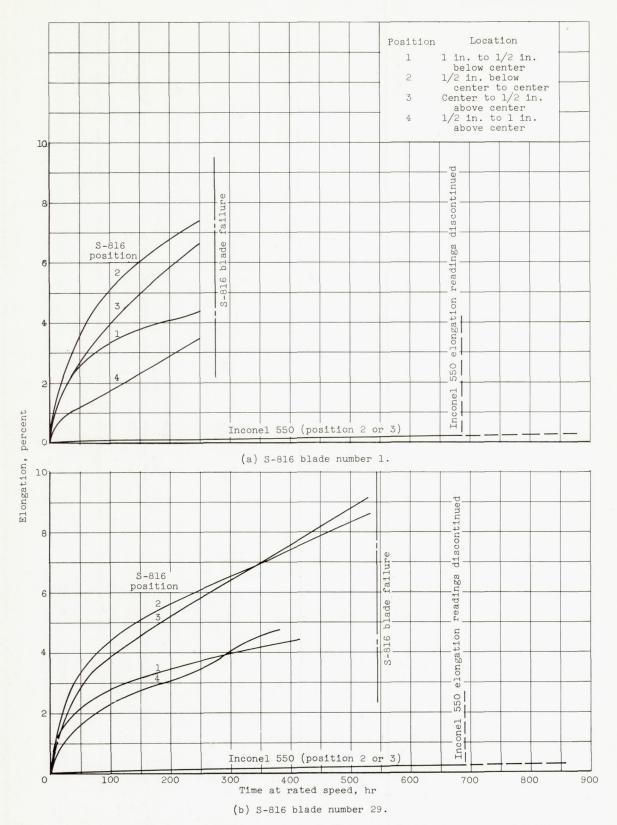
Figure 5. - Maximum elongation of Inconel 550 compared with elongation of S-816.

exhibited considerable elongation during operation. It may be seen in figure 5, that the elongation of the S-816 in the zone  $l\frac{1}{2}$  to  $2\frac{l}{2}$  inches above the blade root was approximately twice that occurring in the gage lengths either above or below this zone. It should be noted that the critical point indicated on figure l(b) occurs near the exact center of this zone.

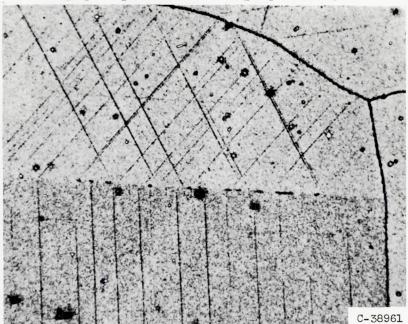
Also, at the leading and trailing edges of blades from all groups, various degrees of slip-plane precipitation were noted (fig. 7(b)). These precipitations at the blade edges indicate that cold-working occurred during forging.

(b) Precipitate in slip planes of grains in areas that may have been cold-worked during forging. (Specimen taken from group 1 blade.)

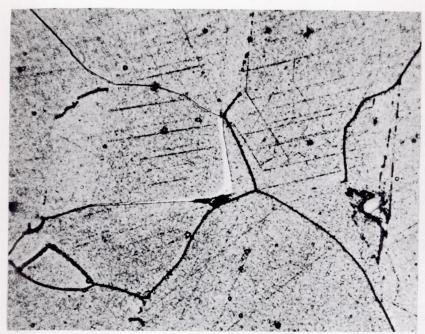
(c) Depletion zone occurring along grain boundaries away from surface of blade. (Specimen taken from group 1 blade.)

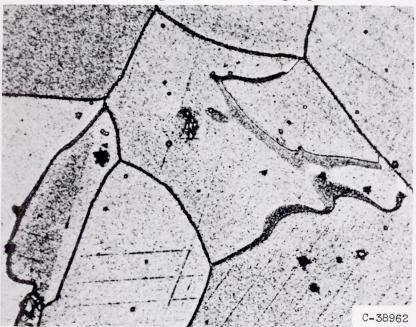
The photomicrograph of figure 7(d) shows an example of a thick segregation of precipitates in a grain boundary. The greatest quantity of this type of grain-boundary precipitate that was noted in the different groups of alloys is shown in figure 7(e).

(d) Type of grain-boundary precipitate noted in localized areas of all groups of blades. (Specimen taken from group 1 blade.)

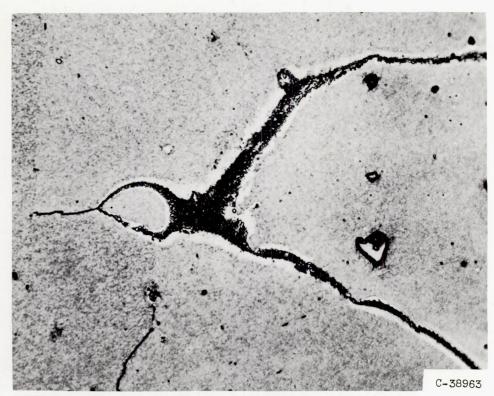
(e) Greatest quantity of grain-boundary precipitate noted. (Specimen taken from group 1 blade.)

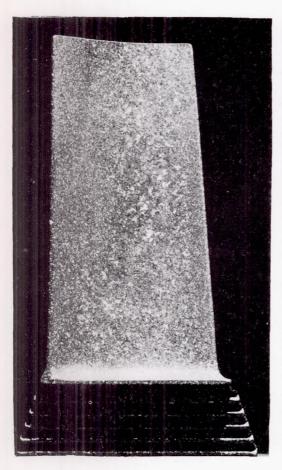
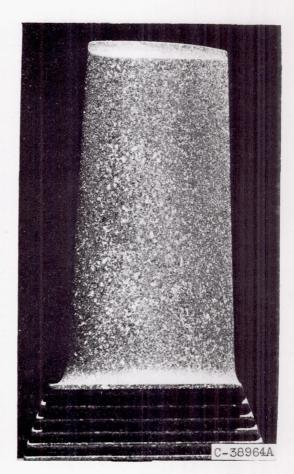
(a) Group 1 blade, largest grains noted.

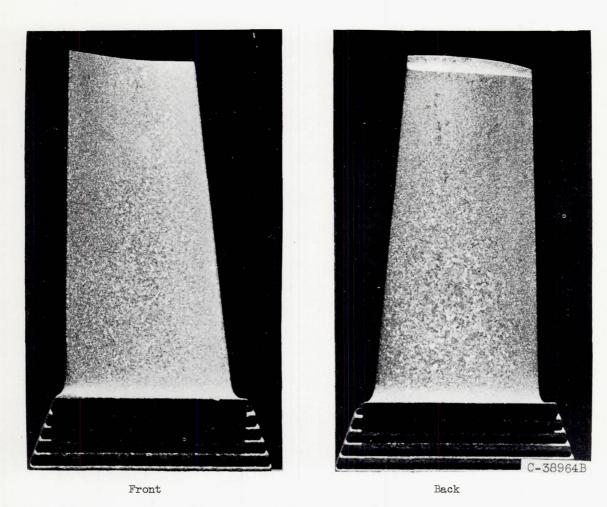
(b) Group 1 blade, smallest grains noted.

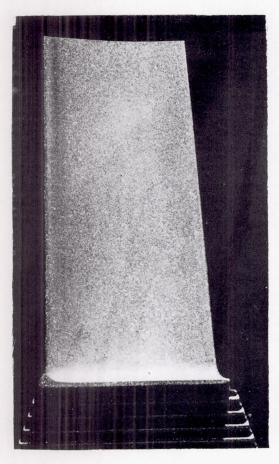
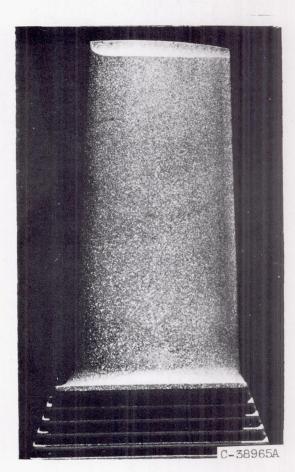
(c) Group 2 blade, largest grains noted.

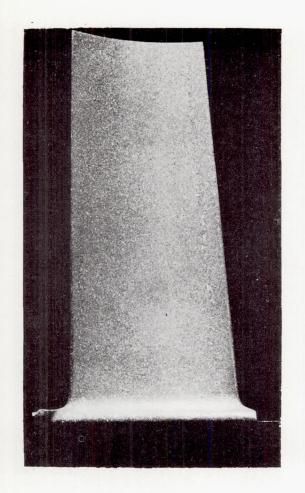
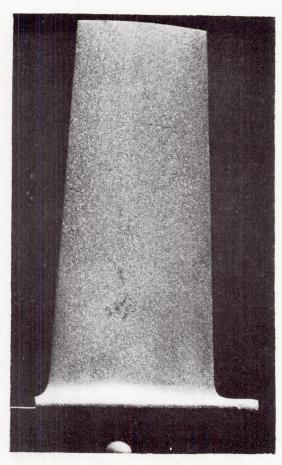
(d) Group 2 blade, smallest grains noted. (Blade did not meet dimensional tolerance.)
Figure 8. - Continued. Macrograin size of Inconel 550 blades. Etchant: 80 parts concentrated HCl, 20 parts H<sub>2</sub>O<sub>2</sub>; immersion.

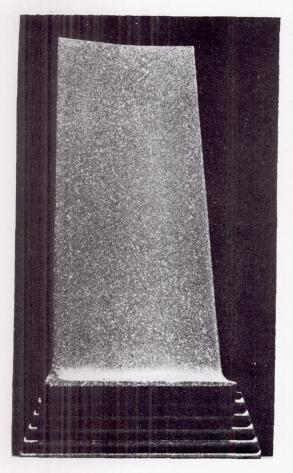
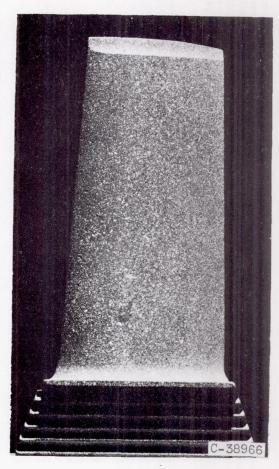
(e) Typical grain size of group 3 blades.

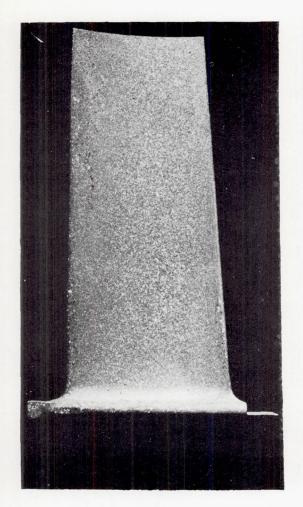
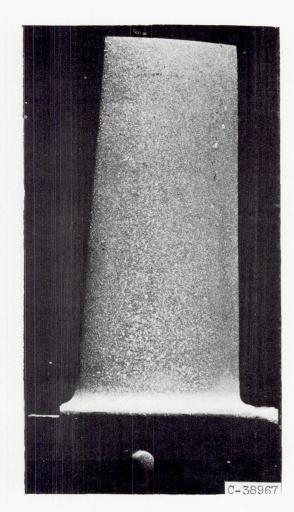
(f) Typical grain size of group 4 blades. (Blade did not meet dimensional tolerances.)

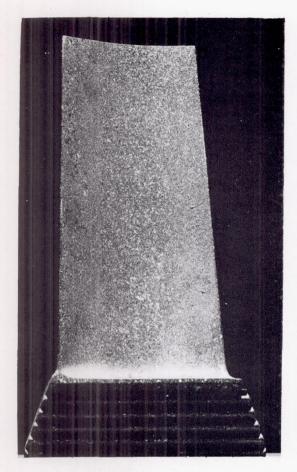
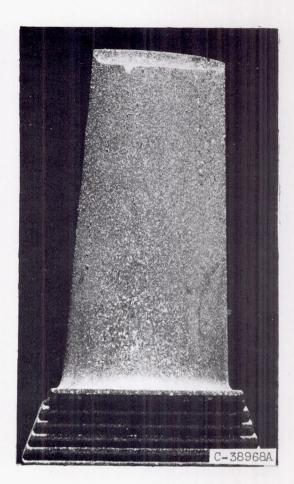
(g) Group 5 blade, largest grains noted.

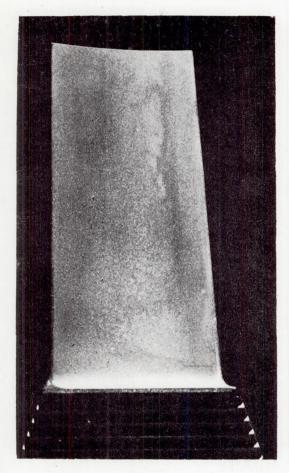
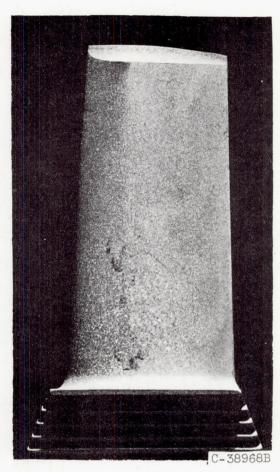
(h) Group 5 blade, smallest grains noted.

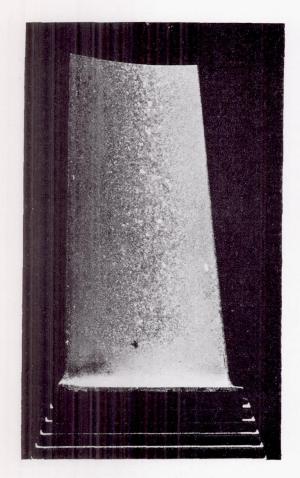
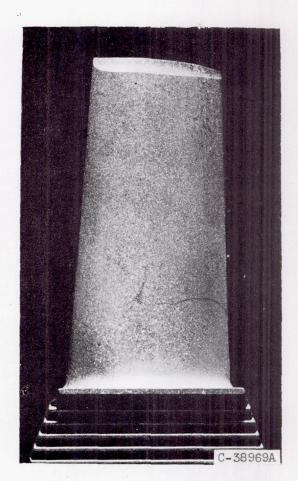
(i) Group 6 blade, largest grains noted.

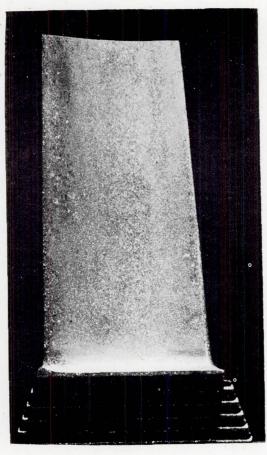
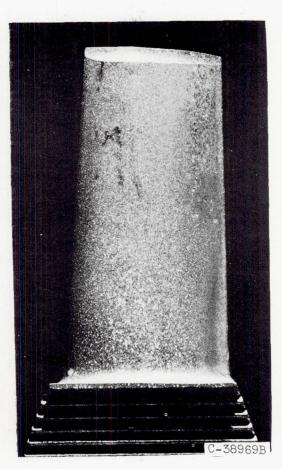
(j) Group 6 blade, smallest grains noted.

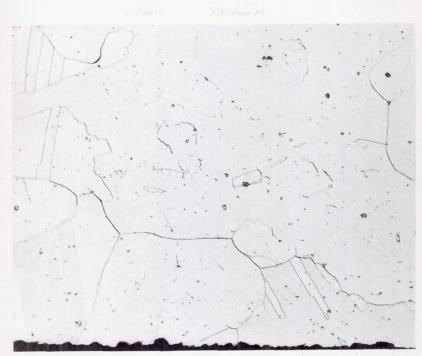
(a) Large grains occurring in trailing edge of group 1 blade. X100.

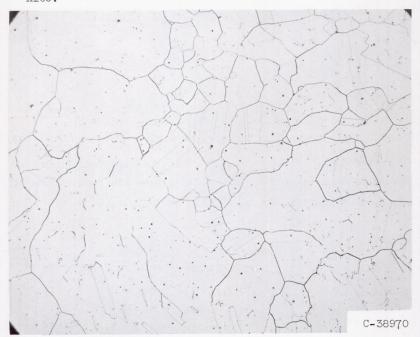
(b) Mixed grain size in cold-worked area of trailing edge of group 1 blade. X50.

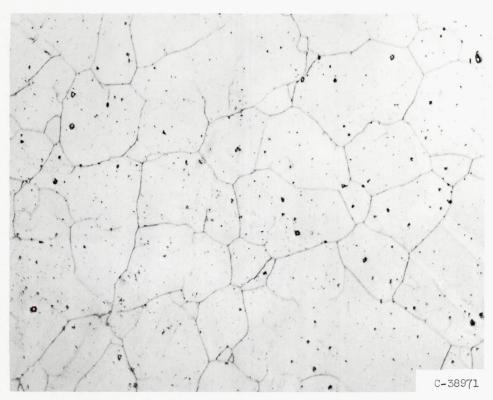
(c) Typical grain size in cross section of group 2 blade. X100.

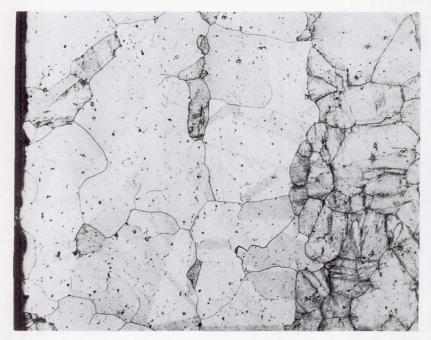
(d) Grain growth in surface cold-worked area of group 3 blade. X100.

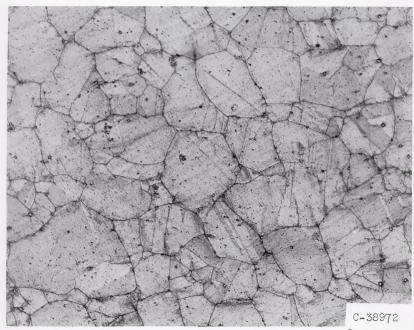
(e) Typical grain size of group 3 blade. X100.

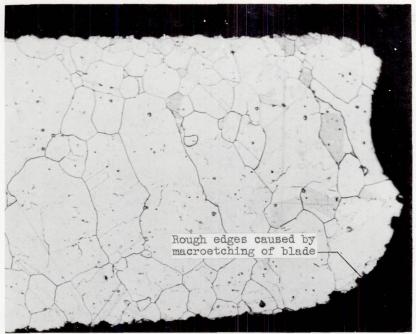
(f) Mixed grain sizes occurring in trailing edge of group 4 blade. X100.

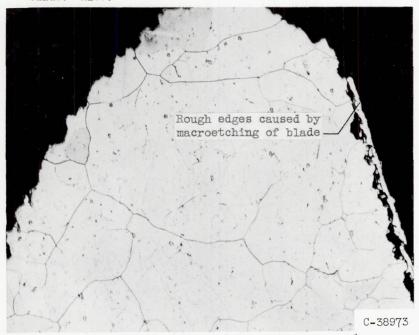
(g) Large grains in leading edge of group 4 blade. X100.

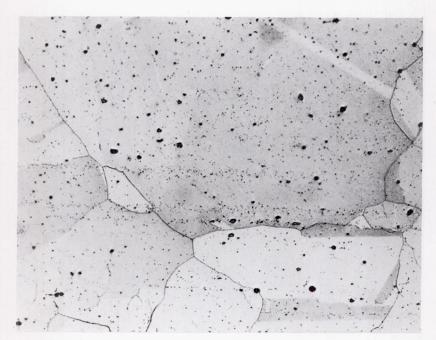
(h) Large grain in trailing edge of group 5 blade. X100.

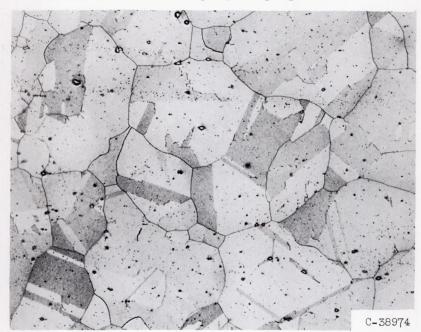
(i) Average grain size of group 5 blade. X100.

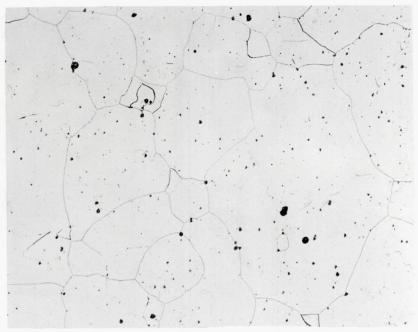
(j) Average grain size in group 6 blades. X100.

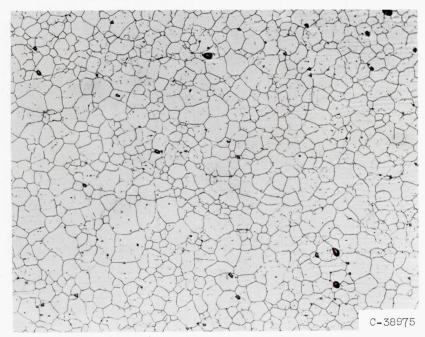
(k) Finest grain size occurring in Incomel 550 blades. (Specimen taken from group 6 blade.) X100.

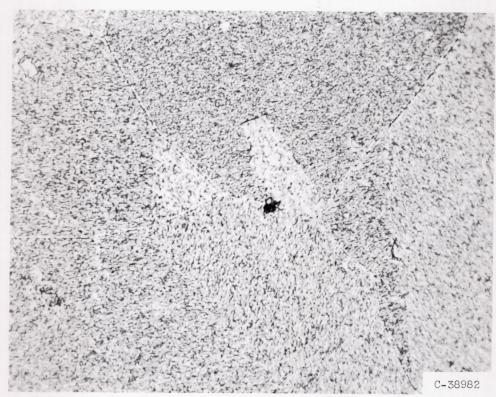
boundaries. Failures appeared to initiate at oxide penetrations and recrystallization occurred in the surface grains of some blades. A typical microstructure of operated blades is shown in figure 11.

Figure 11. - Typical microstructure of Inconel 550 blades after engine operation. (Specimen taken from a group 6 blade which failed at 278 hr rated-speed operation.) Etchant: 5 cc HF, 20 cc glycerine, 20 cc water; electrolytic. X750.

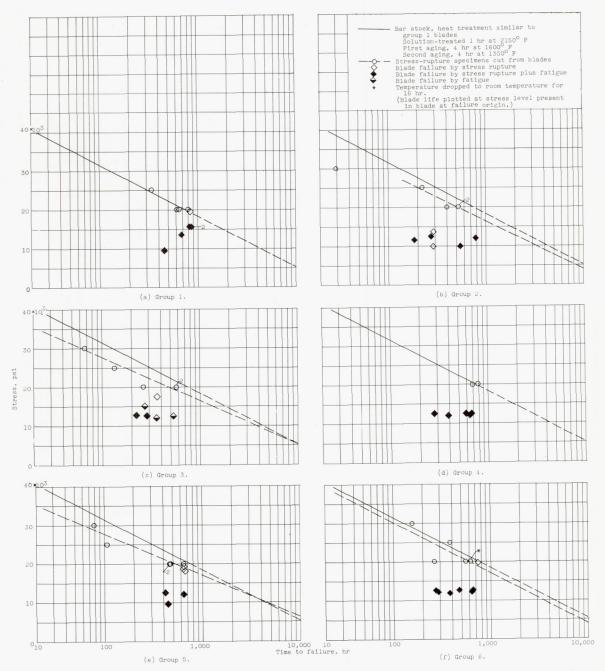
A further indication that fatigue is contributing to the failure mechanism will be evident from the following discussion. In figure 12, the blade failure times are replotted at the stress levels that obtain at the location of the failures. (These levels may be obtained from fig. 1(a).) The stress-rupture curves shown in figure 12 were obtained from the stress-rupture data specimens cut from blade airfoils. Based on any reasonable extrapolation of the stress-rupture curves, the blade lives have been reduced by 70 to 90 percent of that predicted from stress-rupture consideration alone.

Figure 12. - Comparison of blade life and stress-rupture life of bar stock and specimens cut from blades at  $1500^{\circ}$  F test temperature.

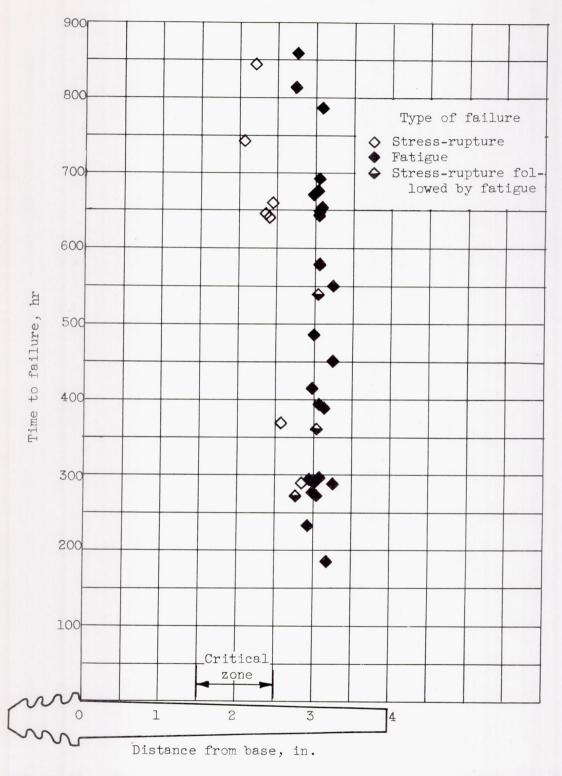
The majority of failures (74 percent) occurred above the "critical zone" (fig. 13) in positions of low centrifugal stress, thus indicating that factors in addition to stress rupture contributed to the failure. It is interesting that all except two of the blades that failed outside the critical zone exhibited fatigue characteristics at the fracture edges and all the blades that failed in the critical zone showed stress-rupture characteristics.

Figure 13. - Occurrence of failures in Inconel 550 with respect to blade length. Damage failures excluded.
